General Technical
Report INT-245

July 1988

Fire Retardant- Caused Corrosion— A 1986 Field Reassessment

Fire Retardant-Caused Corrosion—A 1986 Field Reassessment

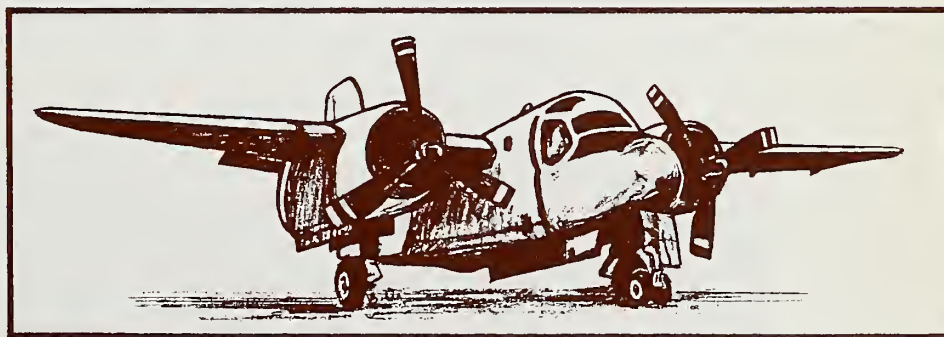
Figure 2—Corrosion of steel end fitting on Aeroquip hydraulic hoses.

2. Corrosion of steel end fittings on Aeroquip hydraulic hoses (fig. 2)

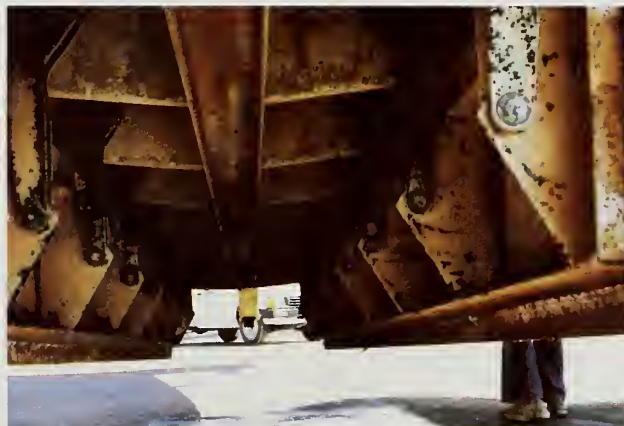
Figure 3—Failure of stranded steel cable.

3. Corrosion of stranded steel cabling (figs. 3 and 8)
